Add-on Armor

By Christian Ankerstjerne

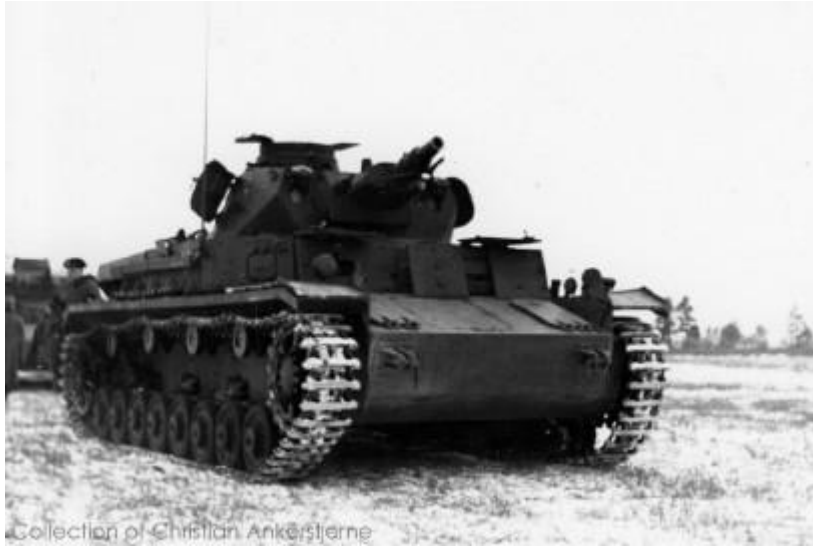
Pz Kpfw IV Ausf. D with add-on armor plates.

Unlike the increased armor thickness, which is intended to increase the resistance to penetration, spaced armor plates serve a different purpose. By adding a relatively thin armor plate in front of the main armor plate, the armor-piercing cap of APC and APCBC ammunition can be stripped from the projectile. This greatly decreases the effectiveness of capped ammunition against face-hardened armor, but has much less influence on uncapped ammunition.

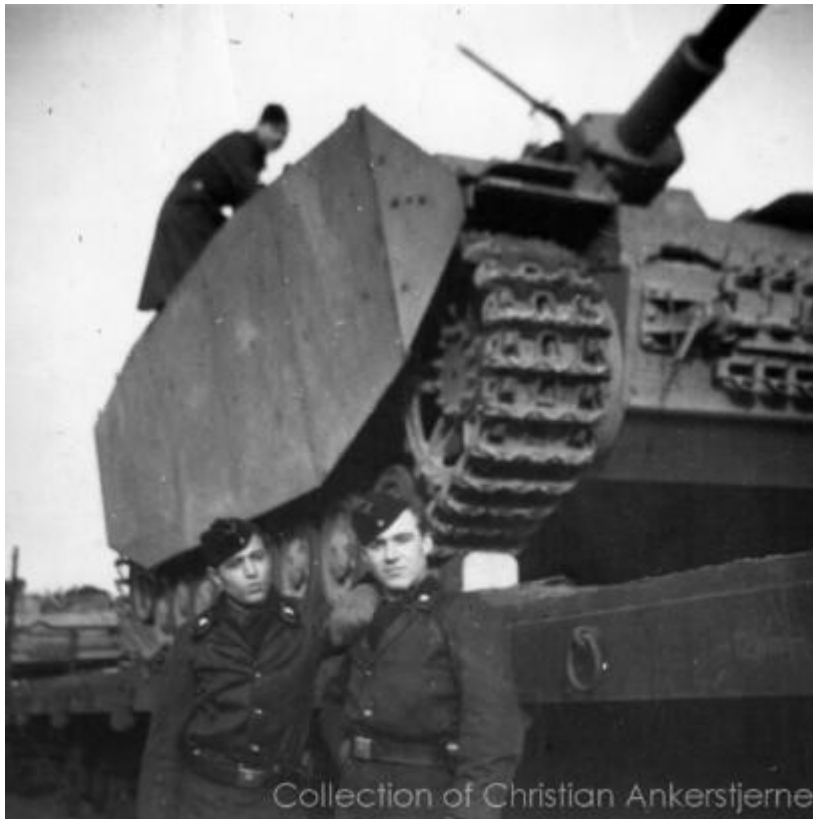
Pz Kpfw IV Ausf. G or H with Schürzen.

To increase protection against anti-tank rifles, 8 mm steel sheets, Schürzen (skirts) were hung on rails along the side of the tanks. These steel sheets caused the shots to tumble, preventing them from penetrating the tank's armor. The Schürzen were divided into sections, allowing a single section to be easily replaced if damaged or lost.

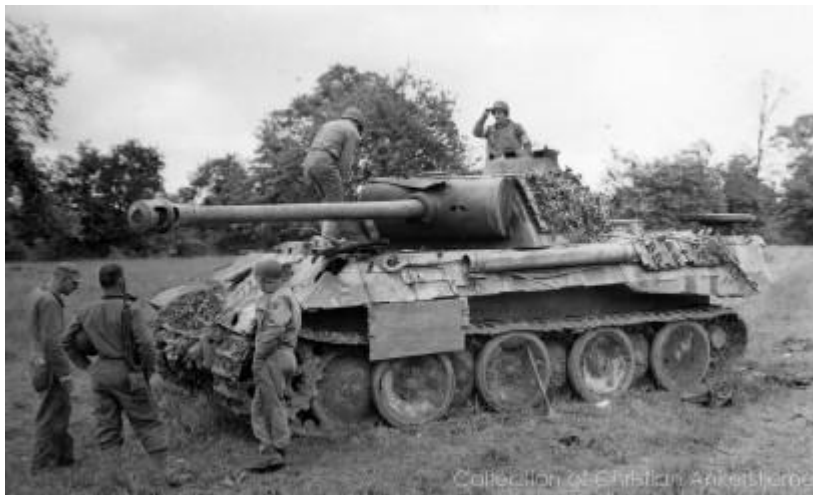
This Pz Kpfw Panther Ausf. A has lost all but one Schützen armor plate.
