## Vehicle Condition Report

Vehicle VIN: 46411057

Year : 1951 Mileage : 9119  
 Brand : Buick Exterior Color : Beige  
 Model : Special Automatic Trim Color : Gray  
 Series : Limited Trim Type : Cloth  
 Body Type : Sedan  
 Drive Type : Rear Wheel Drive  
 Engine : 4.0L, V8 Cylinder Engine, Gasoline Fuel  
 Transmission : 4-Speed Automatic Transmission

Inspection Date : 18 Sep 2012 4:25 PM  
 Inspection ID : 48126  
 Inspector : 4061

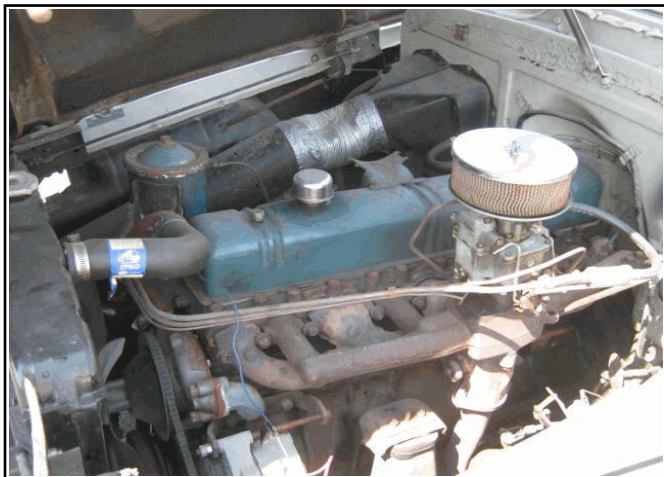
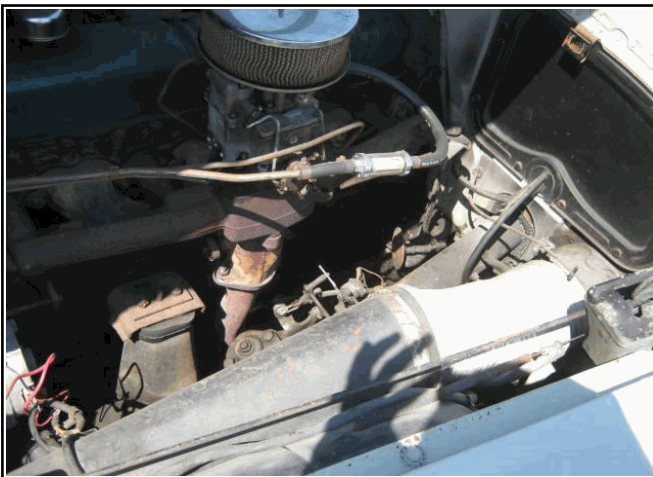
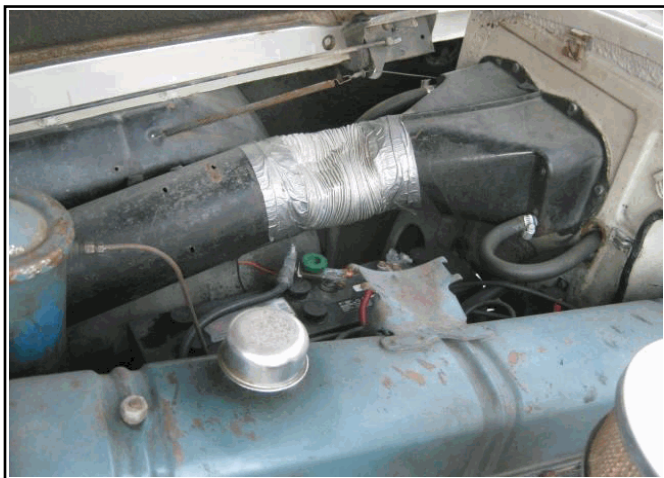
Picture Description : **Engine**

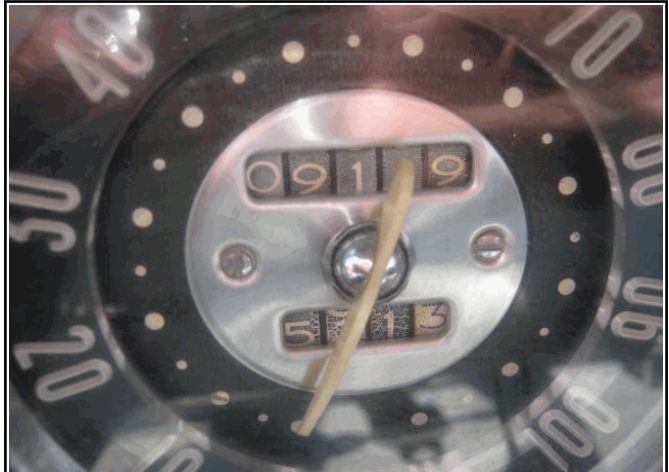
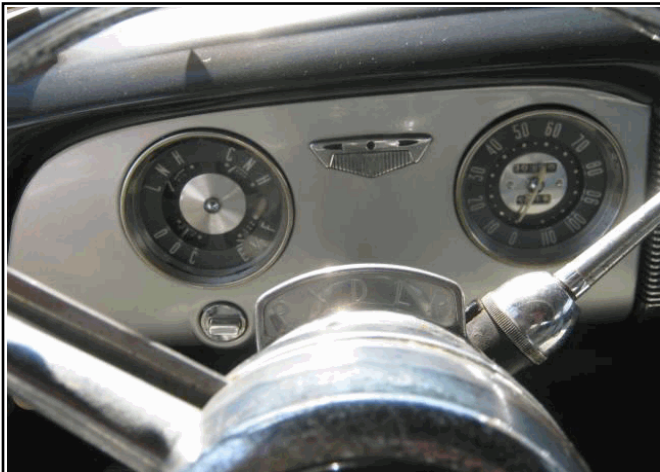
**Inspection Notes :** Vehicle is a 1951 Buick Special automatic. It has a flat head V8 246.9 cubic inch. Unverifiable Miles Due to 5 Digit Odometer. Overall it is a pretty solid old car with only minor issues. The hood has some surface rust, the weather stripping around the windows is cracked. It has a large oil leak coming from underneath the oil pan. The rear differential is also leaking. There are no rear seatbelts. The right rear quarter window is rotted out around the edges. It is all just normal wear from a car this old, nothing major or anything that can not be fixed. Strong motor, good brakes, and very quiet and comfortable. Odometer actually read 09119

Picture Description : **Odometer**

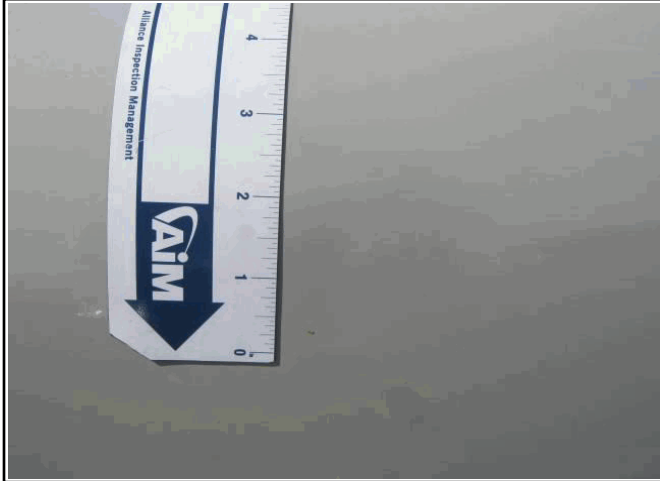
| Area | Type | Size |
|---|---|---|
| 1 Left Rear Quarter Panel | Dent No Paint Damage | Up to 1" |

Picture Description : **Quarter Panel Dent No Paint Damage Up to 1"**

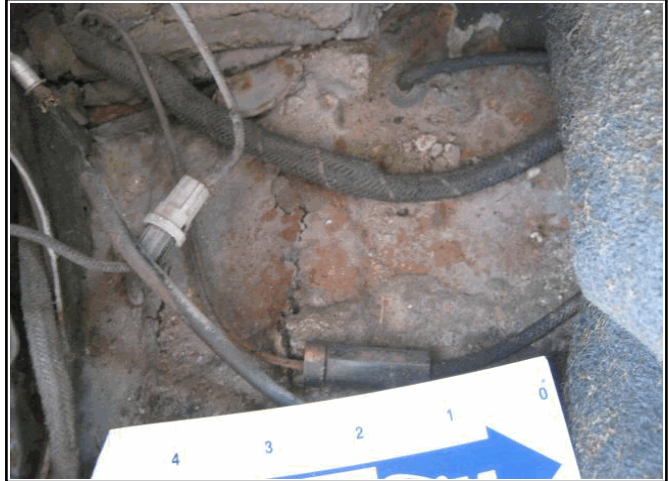
| Area | Type | Size |
|---|---|---|
| 2 Trunk / Cargo Interior | Previous Repair | Bet 3" - 6" |

Picture Description : **Trunk / Cargo Interior Previous Repair Bet 3" - 6"**

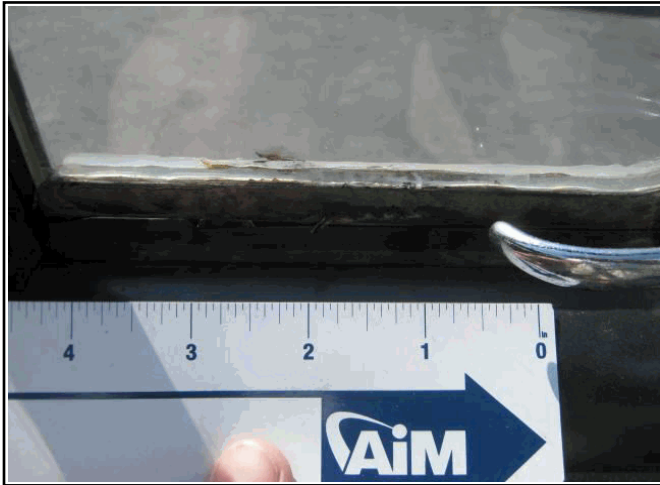
| Area | Type | Size |
|---|---|---|
| 3 Right Rear Door Glass<br>corroded | Other / See Notation | Bet 3" - 6" |

Picture Description : **Door Glass Other / See Notation Bet 3" - 6"**

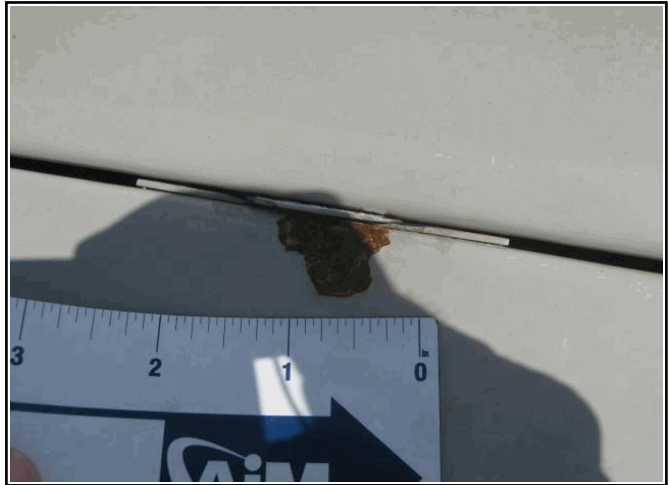
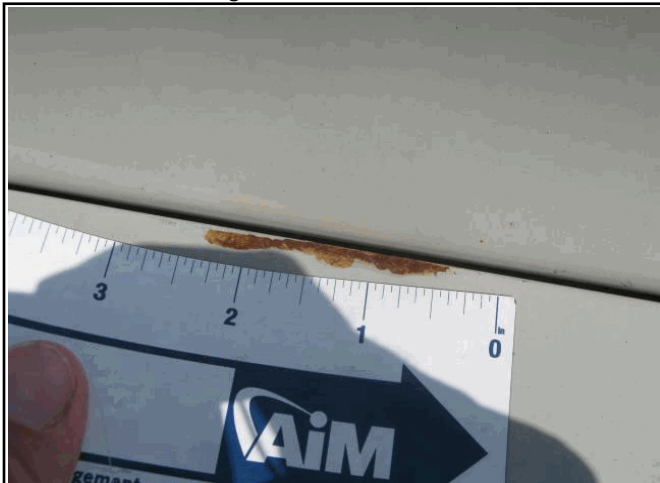
| Area | Type | Size |
|---|---|---|
| 4 Hood Panel<br>Rust | Other / See Notation | Bet 1" - 3 " |

Picture Description : **Hood Panel Other / See Notation Bet 1" - 3"**
